CENTRAL MASSACHUSETTS METROPOLITAN PLANNING ORGANIZATION (CMMPO)

Holden - Paxton - Spencer Route 31 Corridor Profile

September 2014

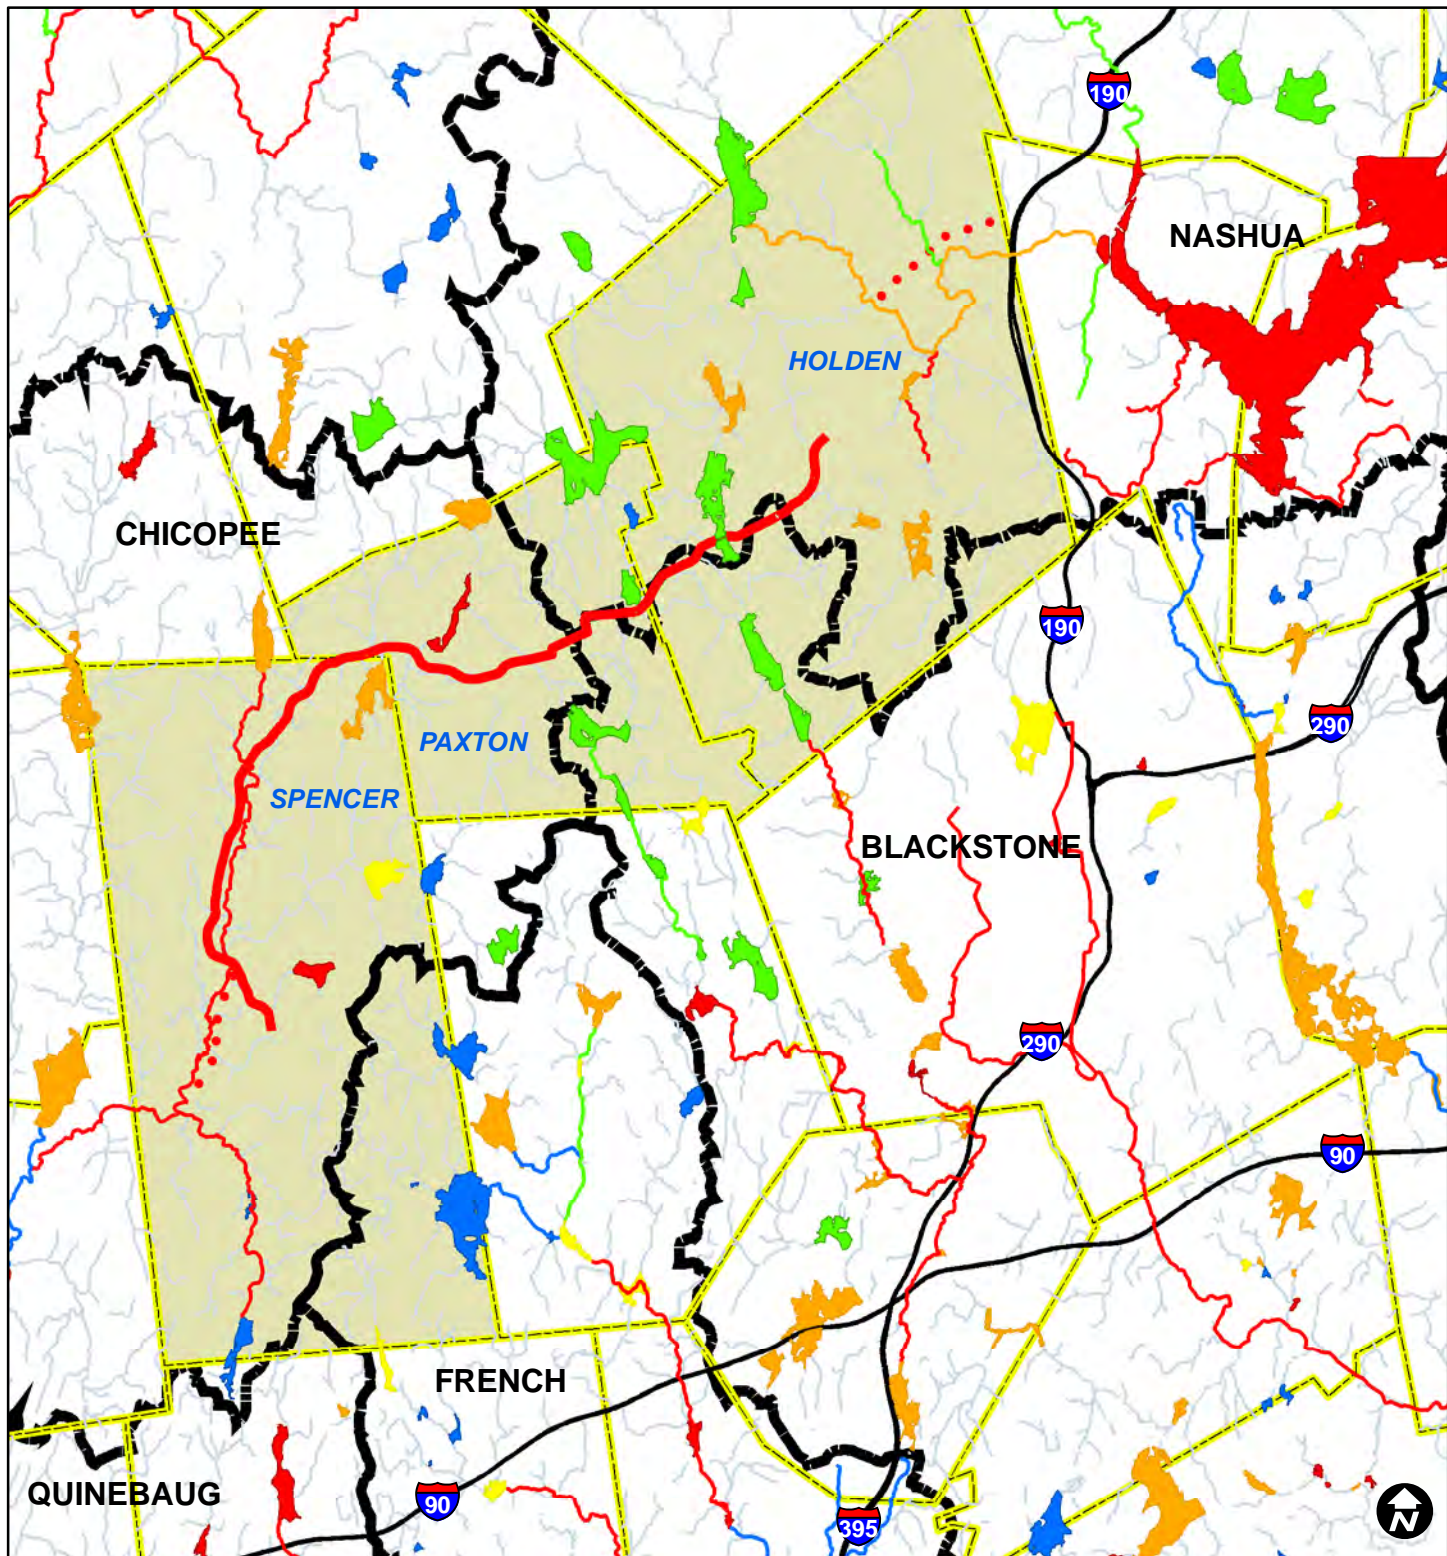
Watersheds and Impaired Waters

Major features of the natural environment were also identified as part of the Route 31 Corridor Profile effort. **Figure 9** shows the major watershed areas within the Route 31 study area. In addition to major watersheds, the figure also indicates impaired waterways in the study area. Under the Clean Water Act, states, territories, and authorized tribes are required to develop lists of impaired waterways. These are waters that are too polluted or otherwise degraded to meet the water quality standards set by states, territories, or authorized tribes. The law requires that these jurisdictions establish priority rankings for waters on the lists and develop a Total Maximum Daily Load (TMDL) for these waters. A TMDL is a calculation of the maximum amount of pollutant that a waterbody can receive and still safely meet water quality standards.

According to the map, the Kendall Reservoir in the town of Holden retains its use, especially as a drinking water supply. In Paxton, the Eames Pond and Turkey Hill Brook require a TMDL. Thompson's Pond, in the town of Spencer, is impaired, but it is not caused by a pollutant while the Sevenmile River also requires a TMDL.

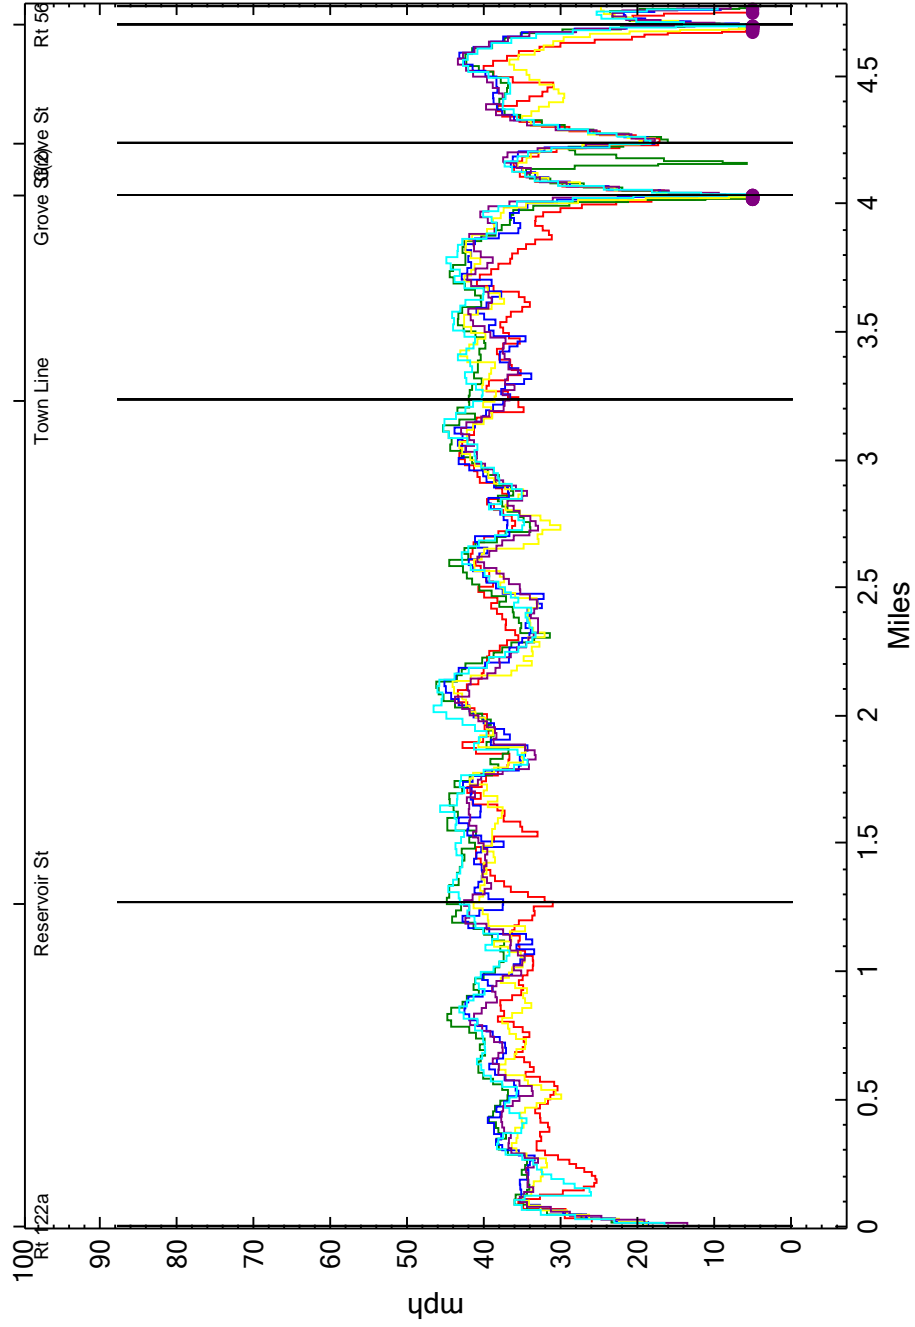
Figure 19

Speed Profile - Route 31 NB - Holden/Paxton

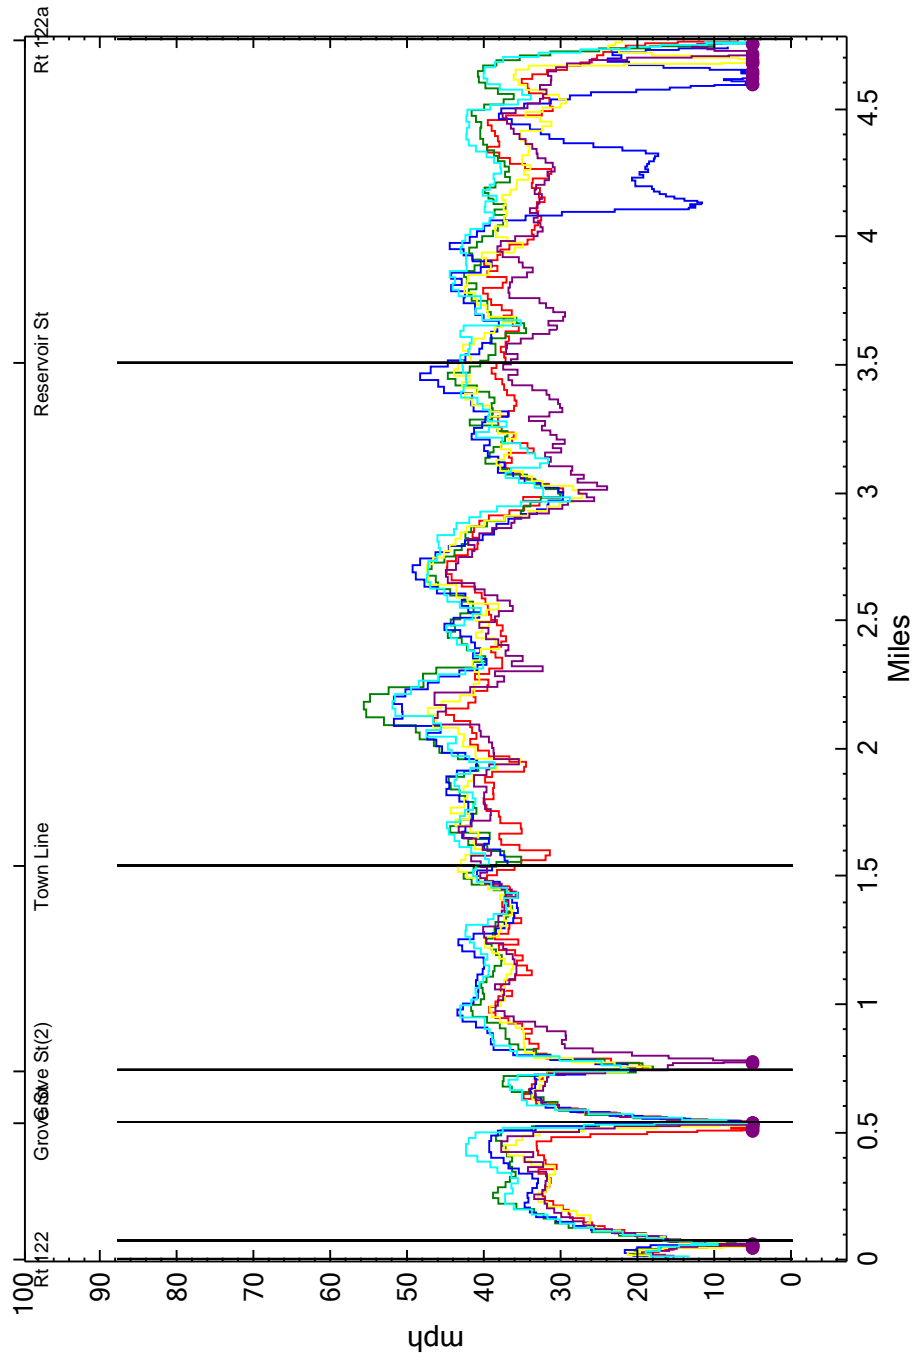
Figure 20

Speed Profile - Route 31 SB - Holden/Paxton

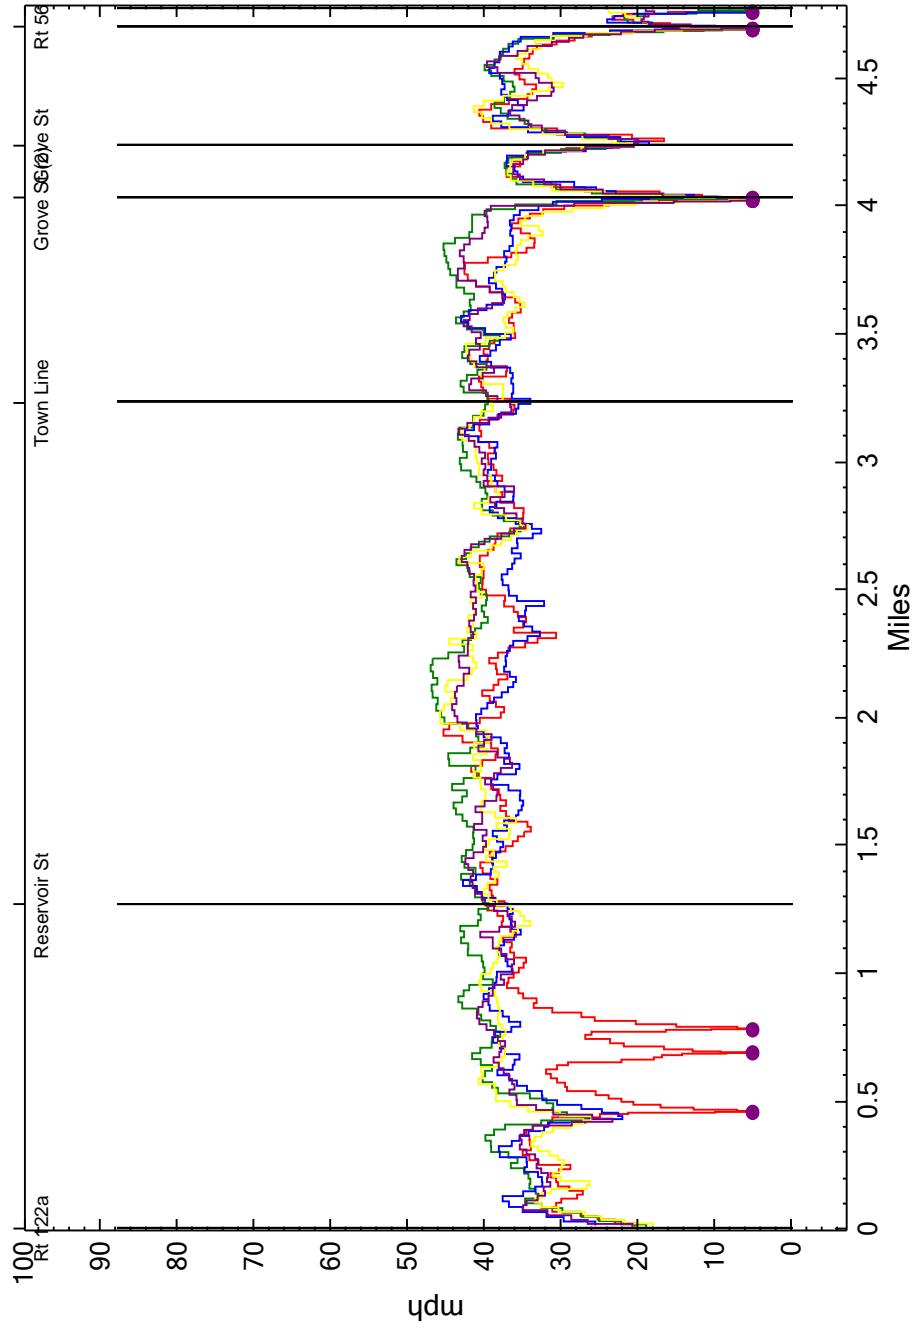
Figure 21

Speed Profile - Route 31 NB - Holden/Paxton

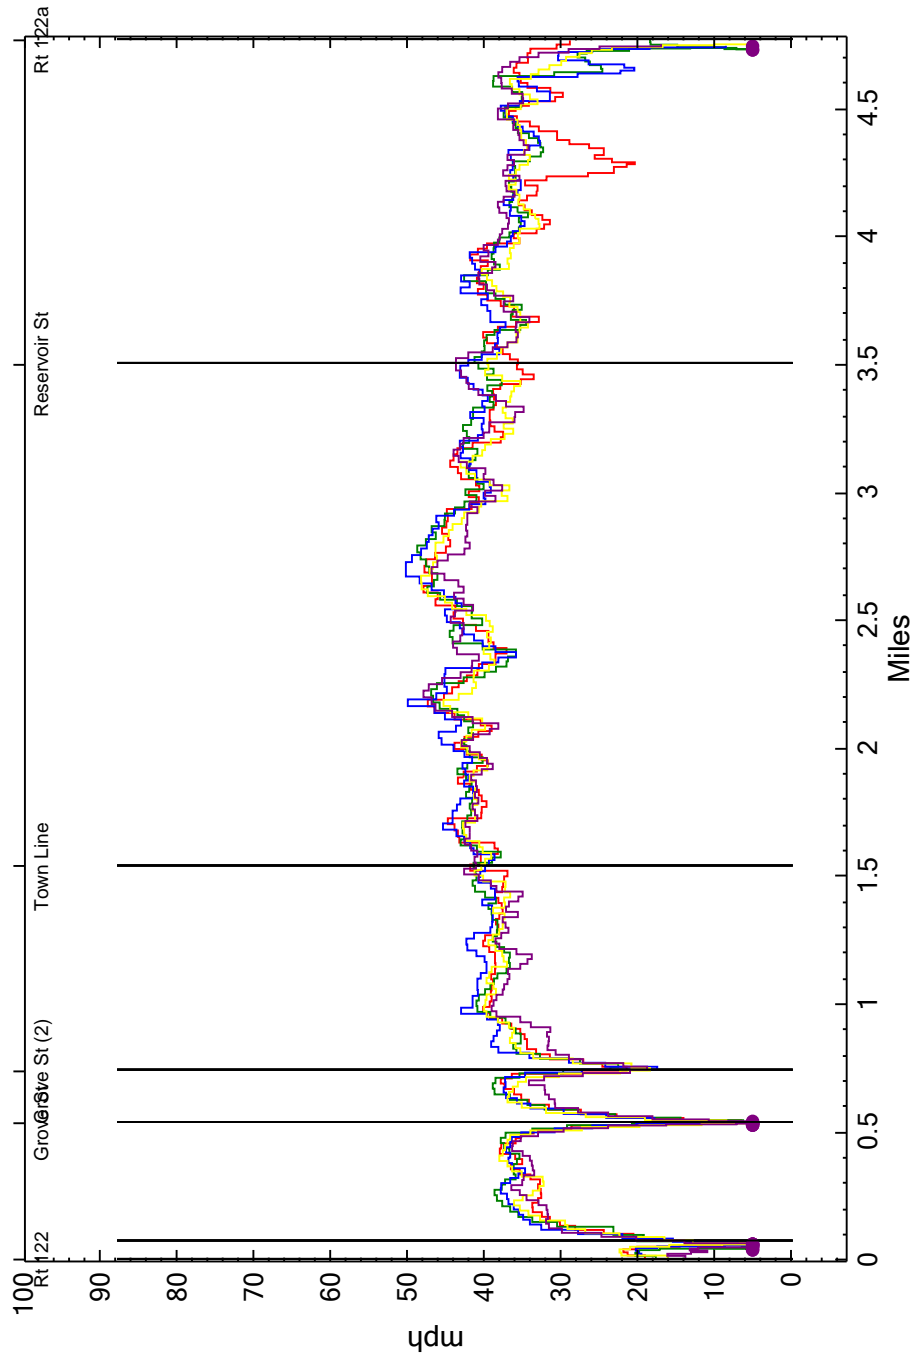
Figure 22

Speed Profile - Route 31 SB - Paxton/Spencer

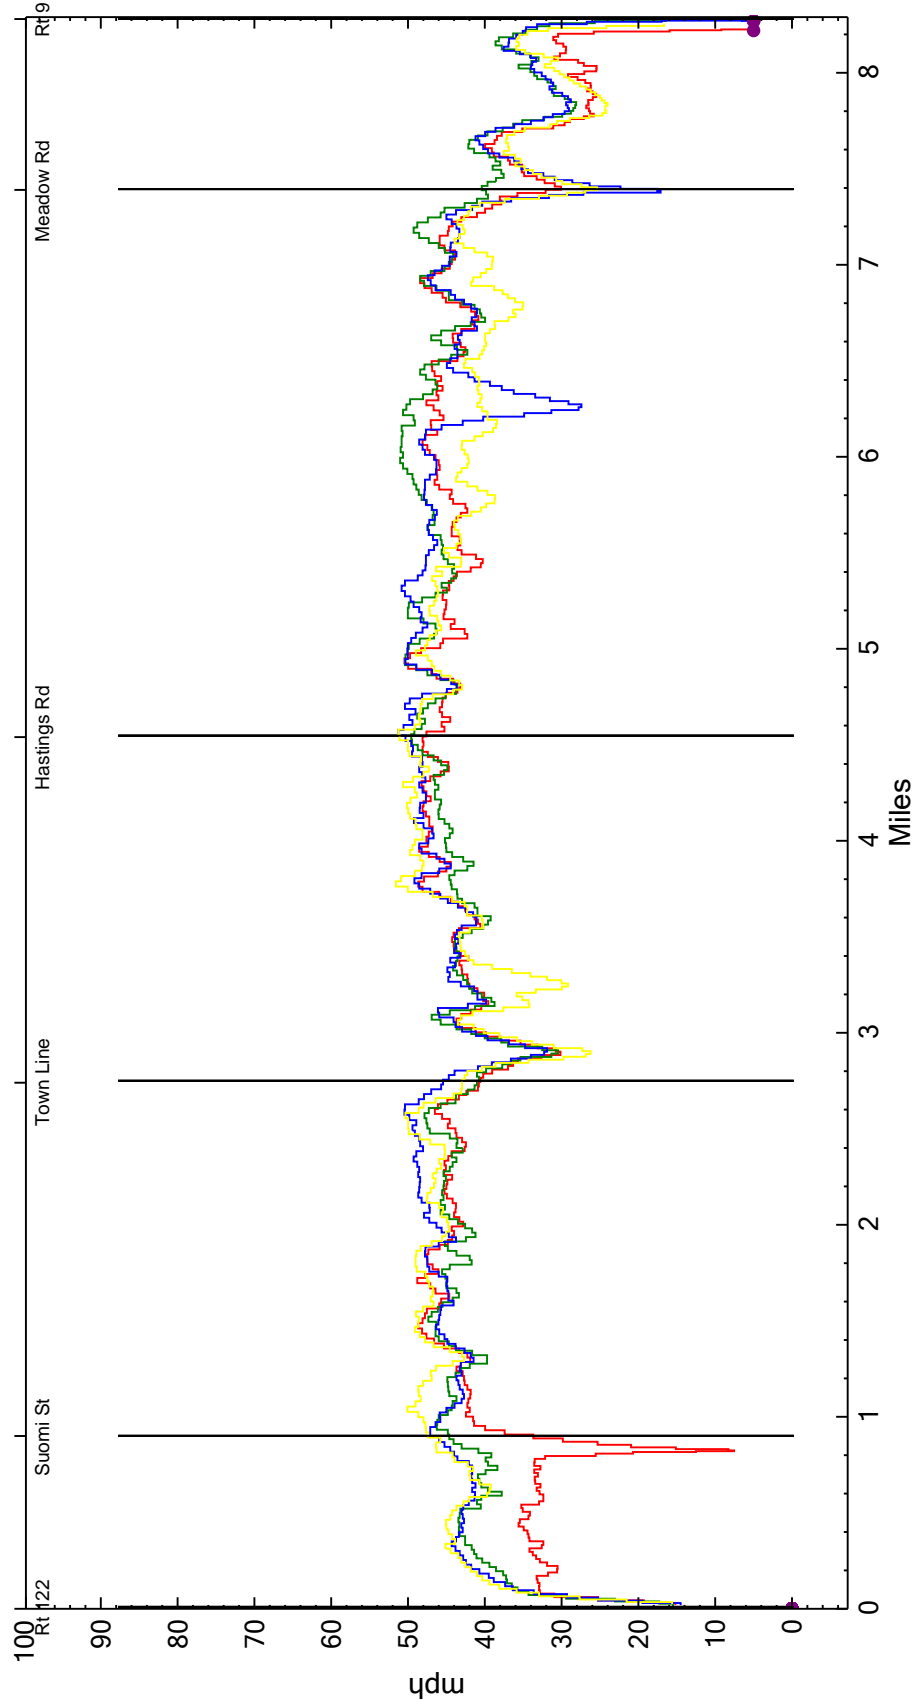
Figure 23

Speed Profile - Route 31 NB - Paxton/Spencer

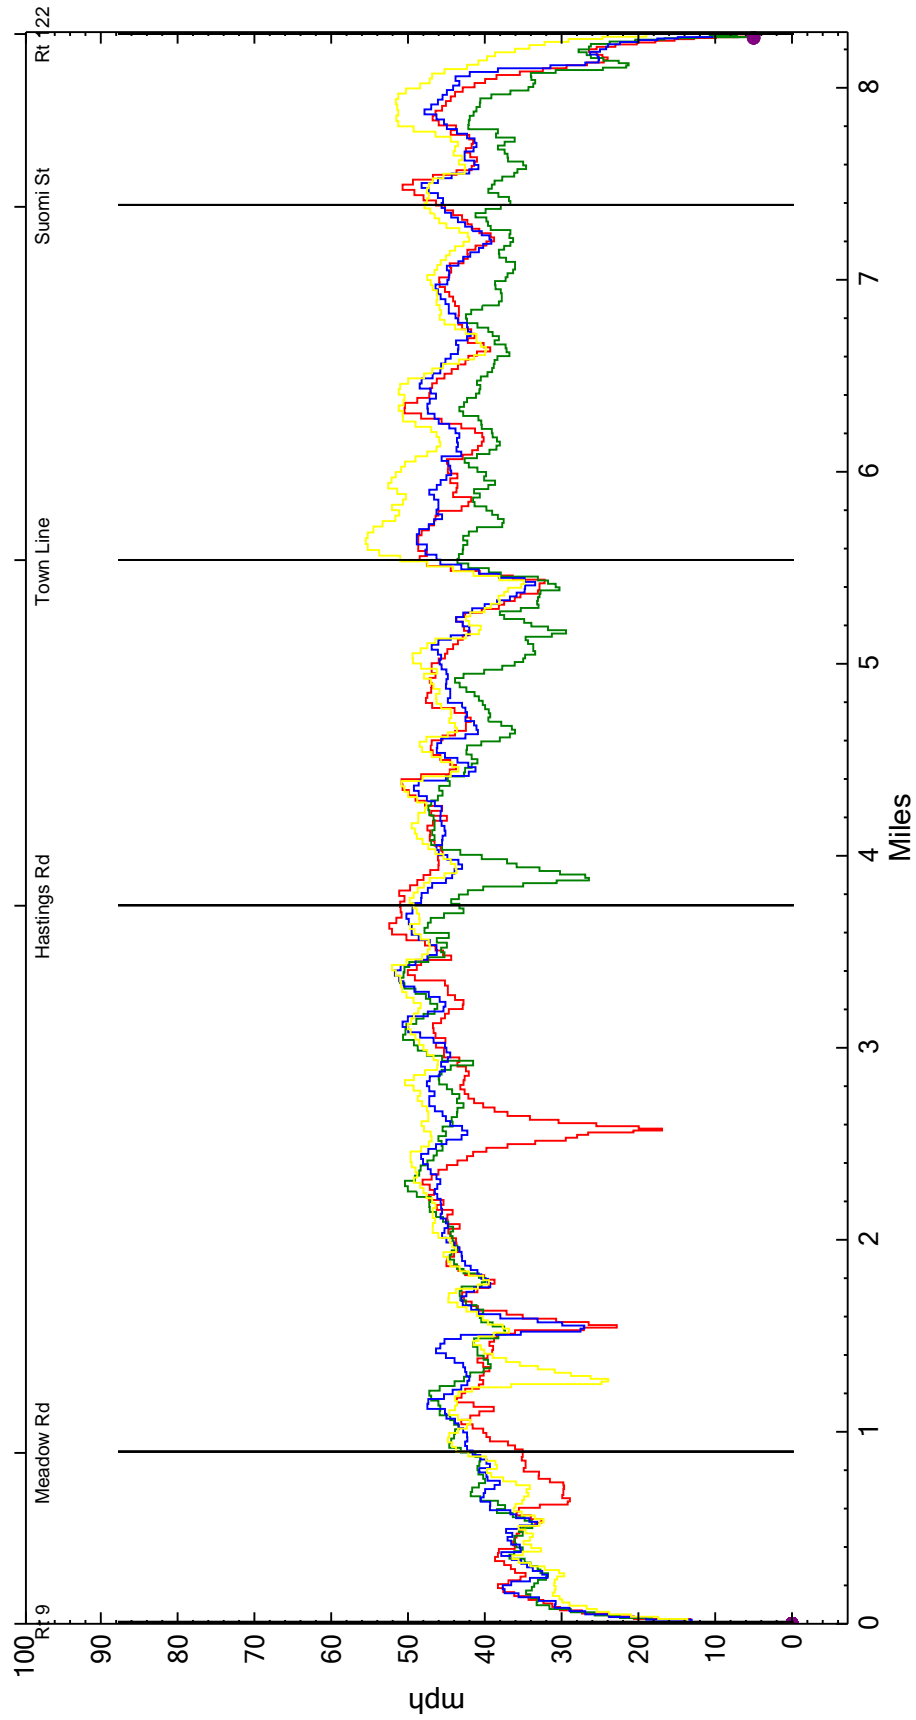
Figure 24

Speed Profile - Route 31 SB - Paxton/Spencer

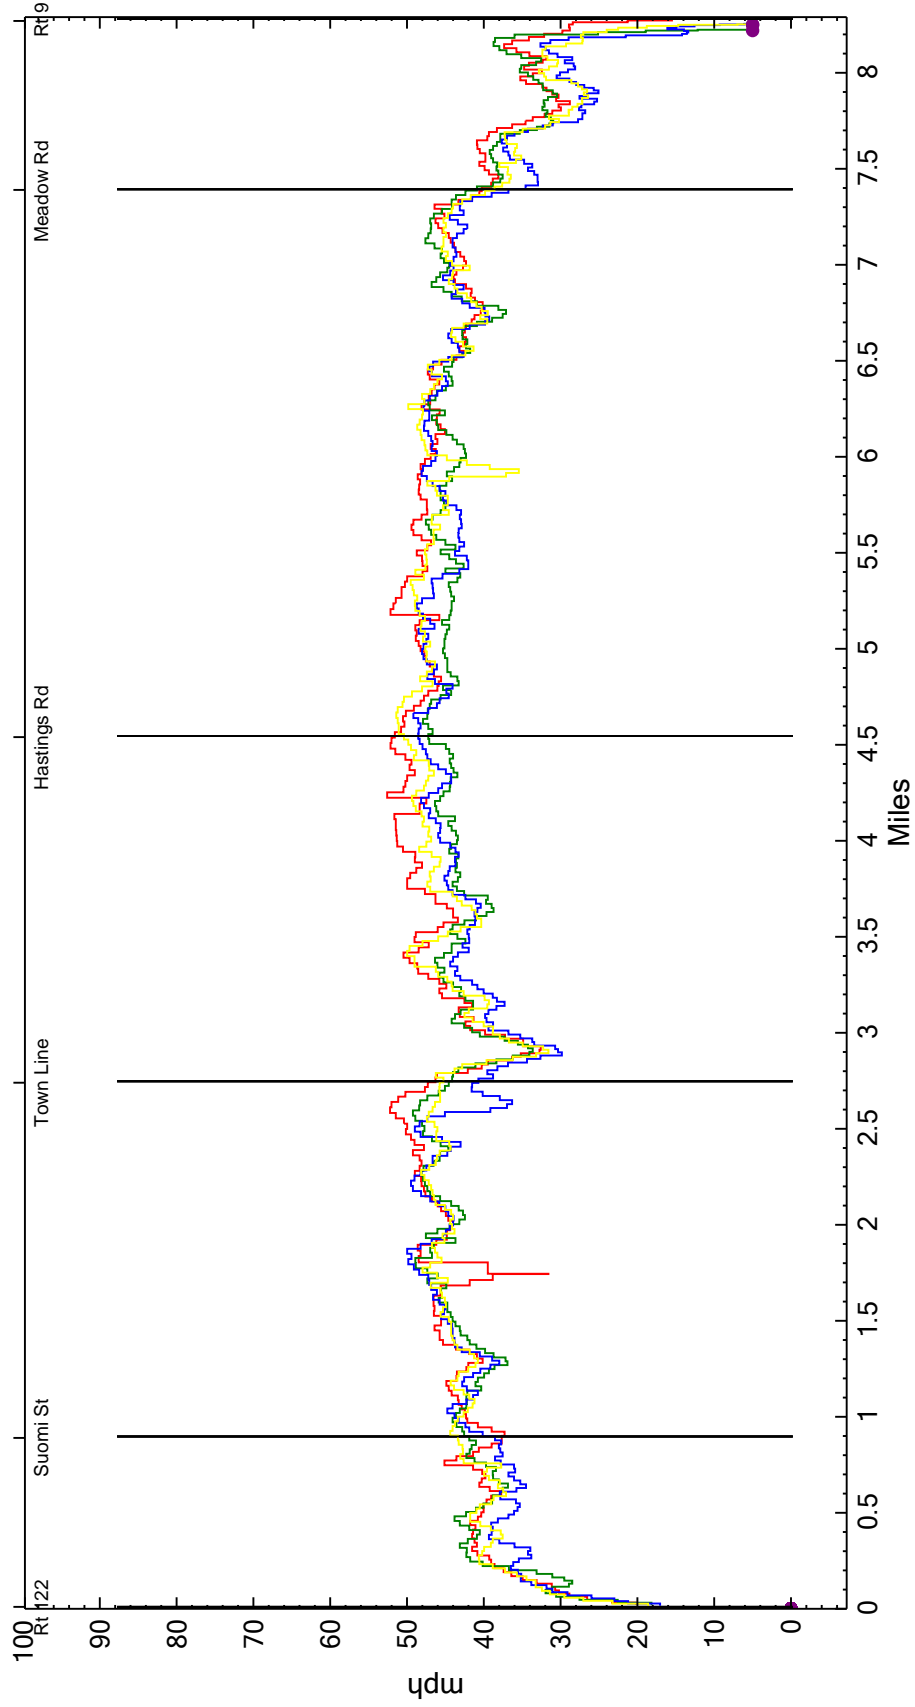
Figure 25

Speed Profile - Route 31 NB - Paxton/Spencer
